## ANALYSIS OF BROWNFIELDS CLEANUP ALTERNATIVES MINGO JUNCTION STEEL WORKS PARCEL A (LADLE HOUSE) NORTH MAIN STREET WEIRTON, HANCOCK COUNTY, WEST VIRGINIA

**CEC Project 164-123.2H2M**

## MINGO JUNCTION STEEL WORKS NORTH END BUILDINGS LADLE HOUSE WEIRTON, WEST VIRGINIA (HANCOCK COUNTY)

ASBESTOS SURVEY REPORT

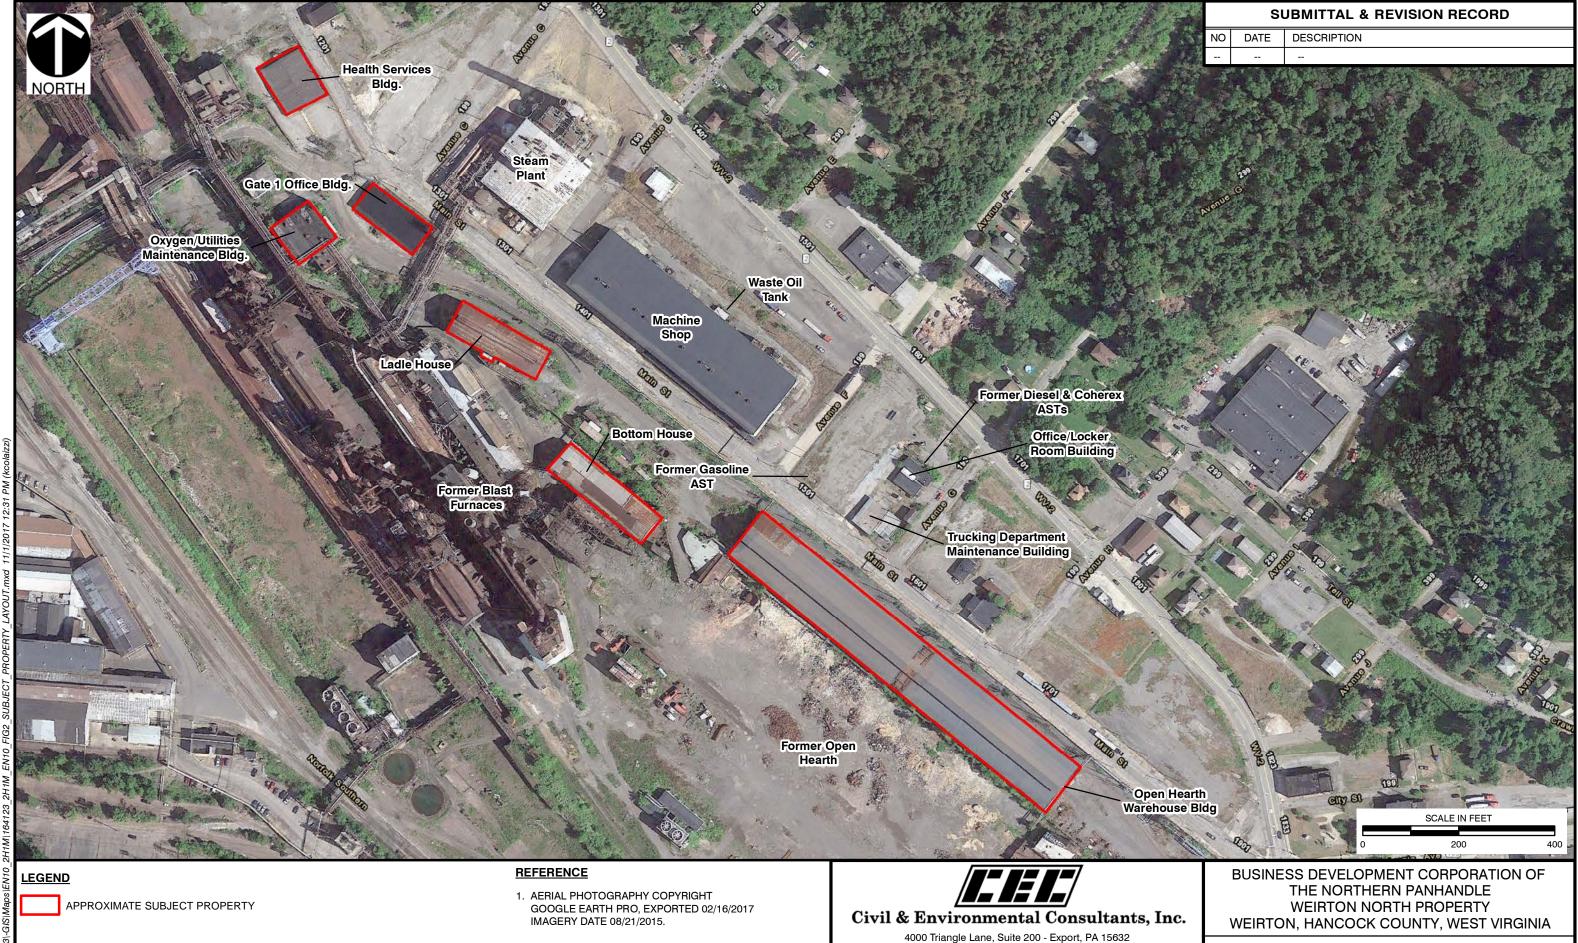
SUBJECT PROPERTY LAYOUT MAP

The Site covers approximately 0.34 acres and is located along North Main Street in the City of Weirton, Hancock County, West Virginia. The Site contains the former Ladle House, a 15,000 square foot steel-framed and sided structure with concrete foundations and floors. The Site is located in a mixed-use area consisting of commercial, industrial and residential properties. The Site layout is shown on Figure 1.

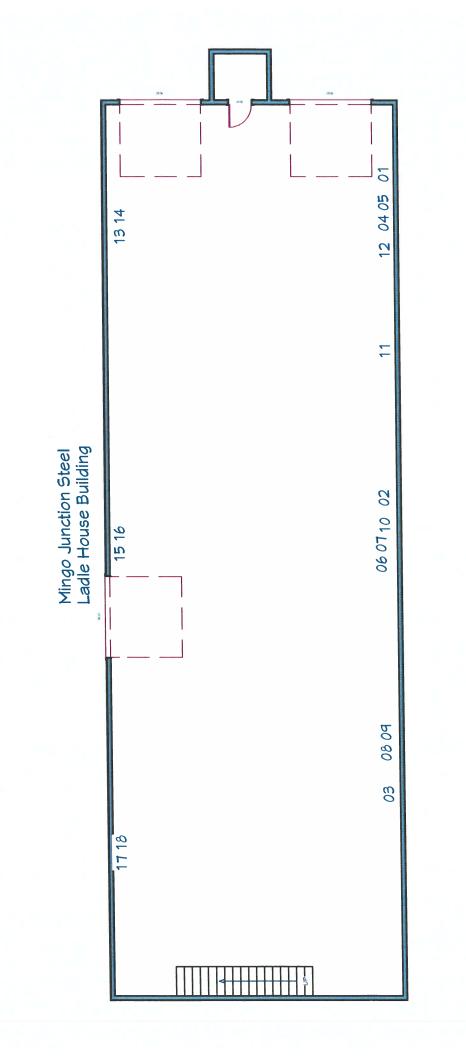
Appendix B – Sample Location Diagram

Bulk samples of suspect asbestos containing building materials were collected throughout the building. A total of eighteen (18) samples, (35) including splits were collected at this time. Of those samples, fourteen (14) were identified as being ACM. An asbestos containing material is defined as any material containing greater than one percent (>1%) asbestos. For a summary of all identified ACM, refer to Table 1—Asbestos Containing Materials. The complete listing of materials sampled is indicated in Appendix A—Building Inspection Results. Refer to Appendix B- for Sample Location Diagrams.

All asbestos abatement work should be conducted by a licensed asbestos abatement contractor prior to implementing any demolition activity procedures. Prior to the initiation of any asbestos abatement work, ensure that all of the delegated state and local pollution control agencies in the area and / or the EPA regional office are notified.
