**ANALYSIS OF BROWNFIELDS CLEANUP ALTERNATIVES  
NEWELL PORCELAIN SITE  
FIFTH & HARRISON STREETS  
NEWELL, HANCOCK COUNTY, WEST VIRGINIA**

**CIVIL & ENVIRONMENTAL CONSULTANTS, INC.  
EXPORT, PENNSYLVANIA**

**CEC Project 164-123.2H2H**

**November 2017**

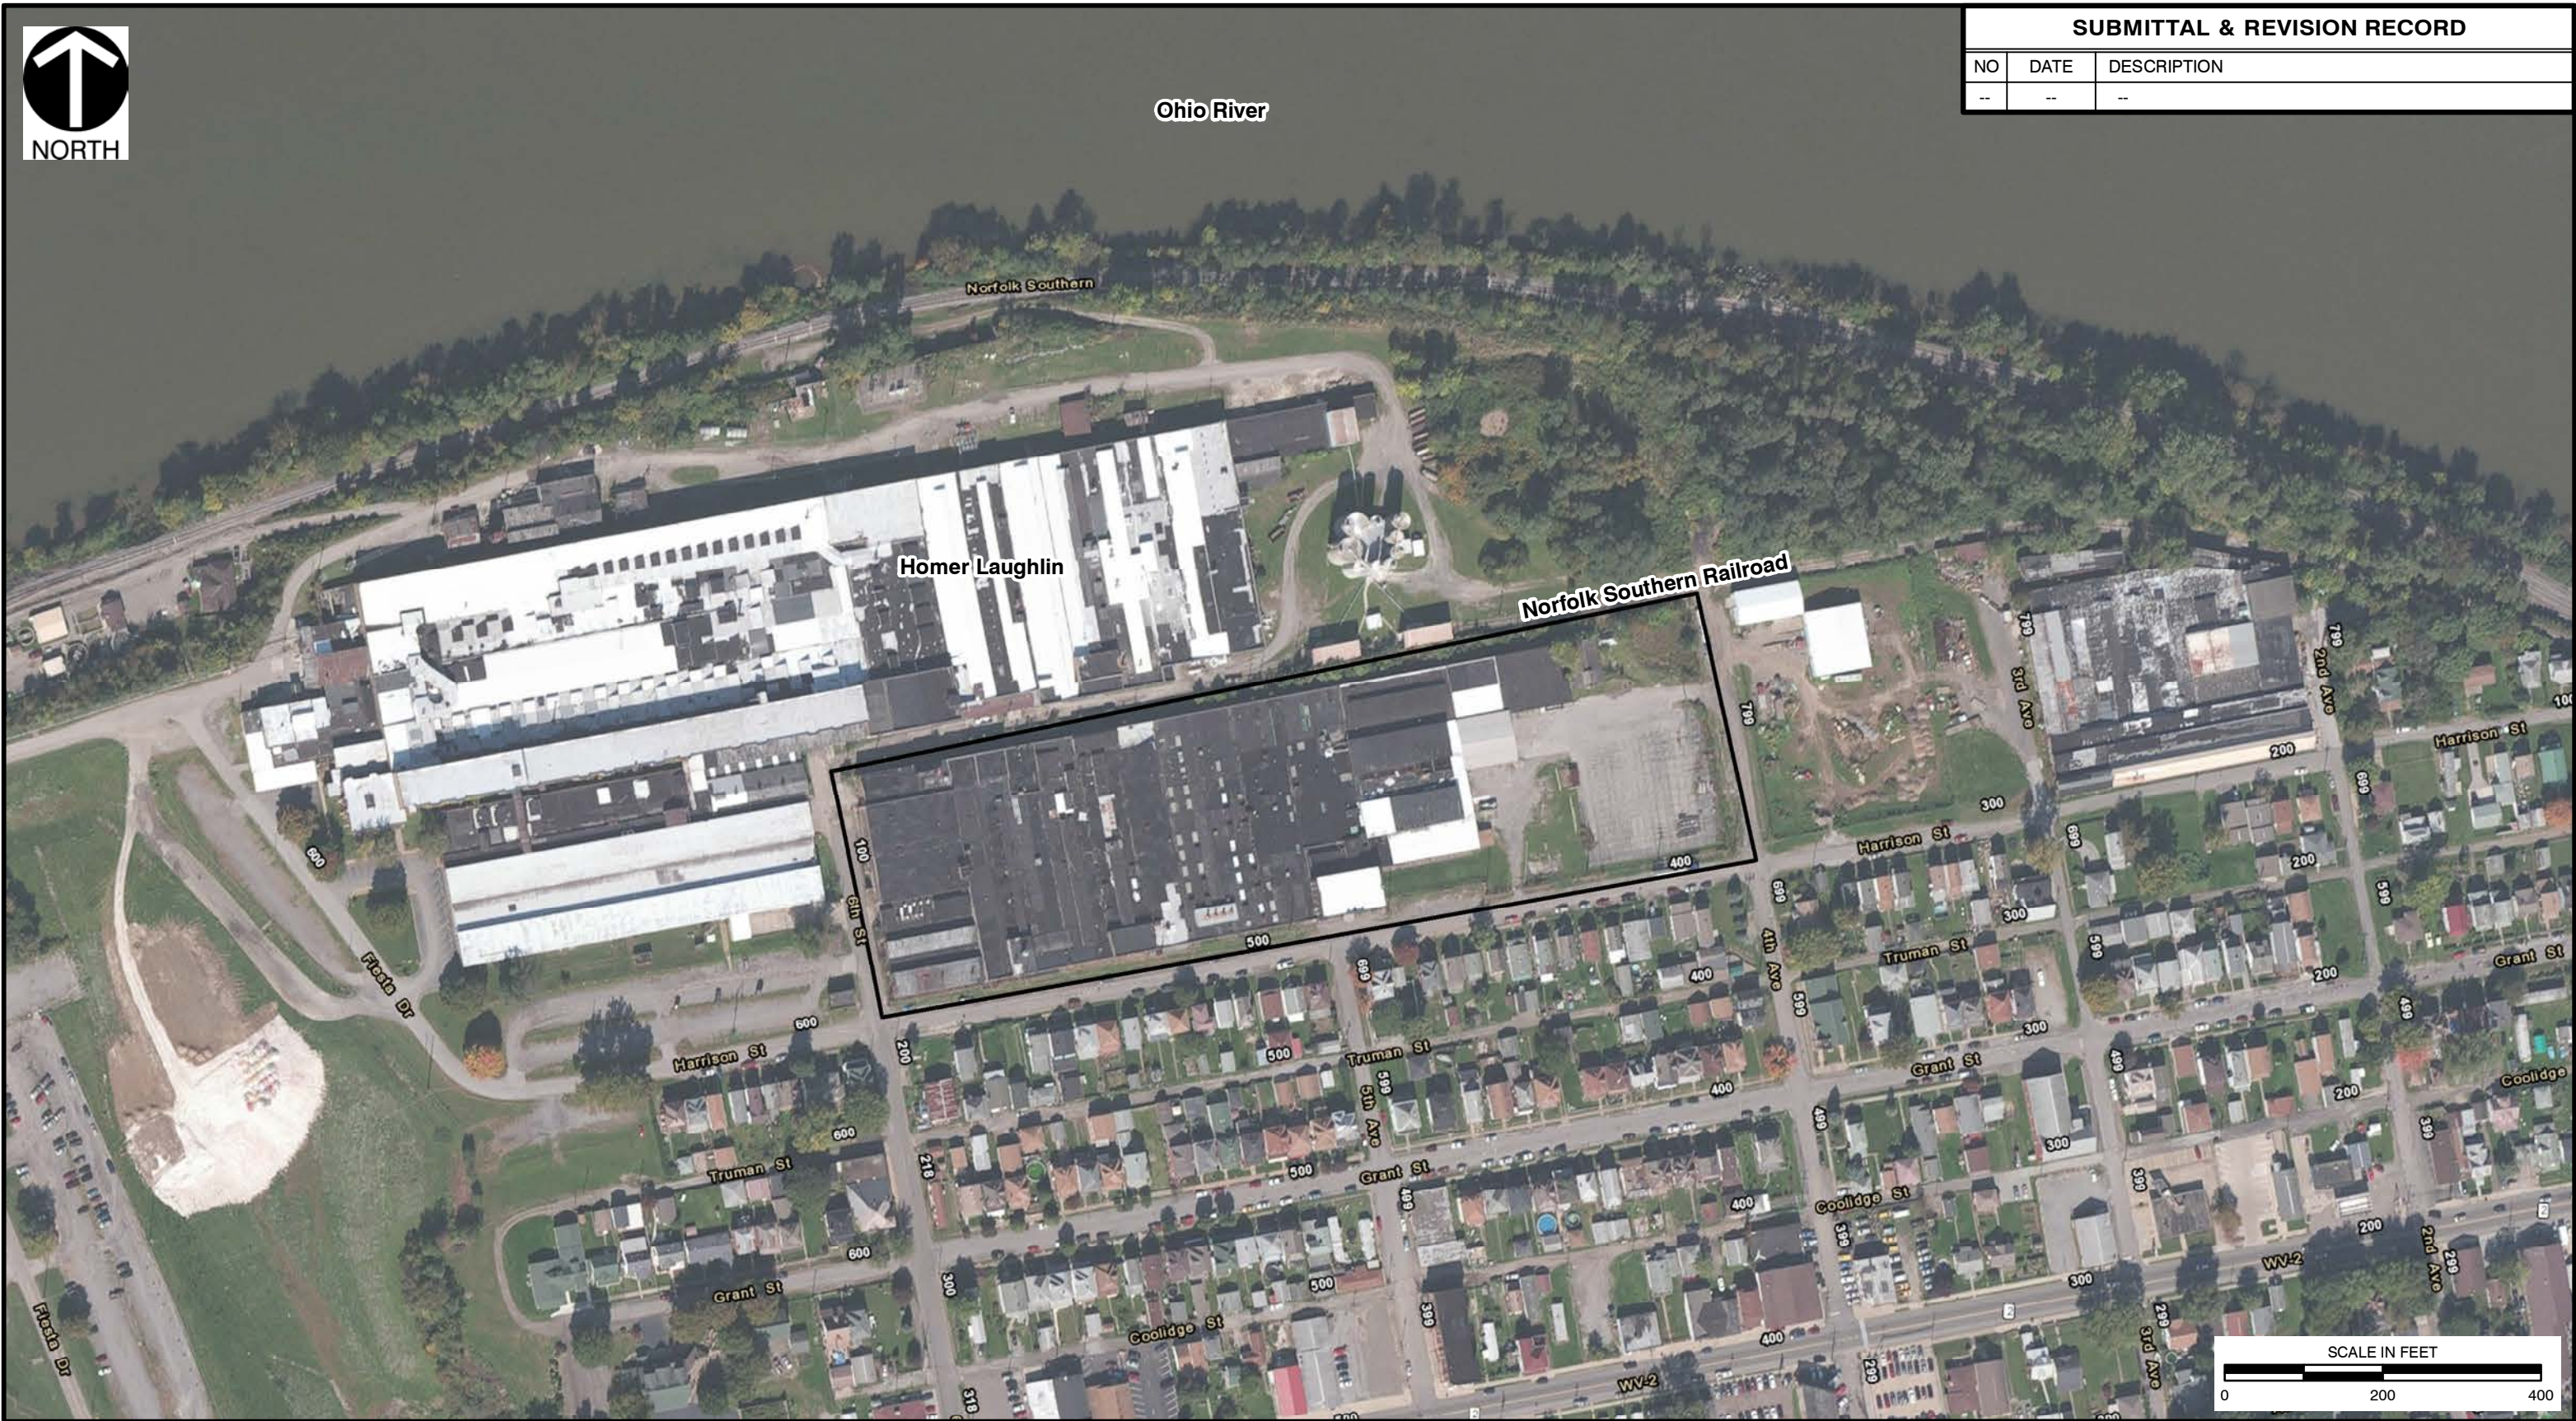
FIGURE NO:  
\* Hand signature  
on file

The Site covers approximately 8 acres and is located along at Fifth and Harrison Streets in the City of Newell, Hancock County, West Virginia. The majority of the Site covered by buildings or pavement. The main manufacturing building, much of which is deteriorated and determined to be structurally unsound, covers approximately 5.9 acres. Three smaller buildings situated on concrete slab-on-grade foundations are located near the northeastern corner of the Site. These include the Frit House building, the Gas House, and the Pump House. The Site is located in a mixed-use area consisting of commercial, industrial and residential properties. The Site layout is shown on Figure 1.

SUBJECT PROPERTY LAYOUT MAP

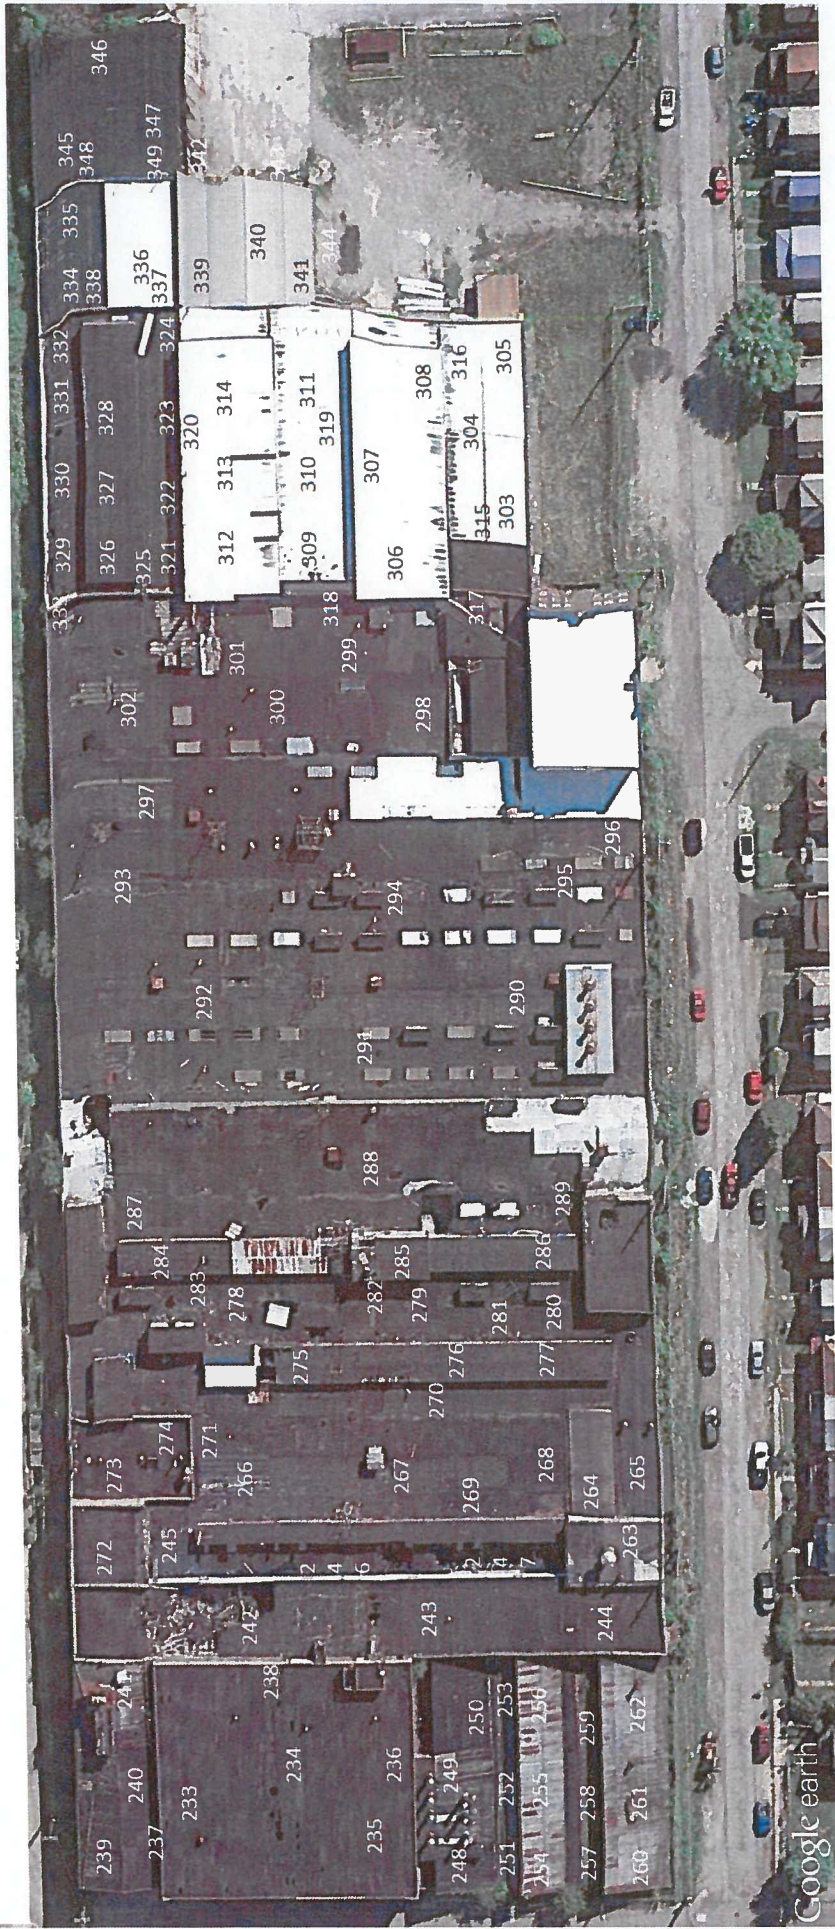
## Newell Porcelain Plant Roofs

- Roofs and floors were collapsed in various areas throughout the facility.
- Facility rooftops were found to be structurally unsound during our on-site investigation. MAEC survey personnel sampled accessible roofing materials from collapsed areas and holes within the plant. All roofs were surveyed with the exception of the Office Building roof as per the direction of the current site owner Haydall Redevelopment, LLC. The Office Building roof / associated flashing is assumed to be asbestos containing and must be treated as such if demolition procedures are implemented.
